TECHNICAL REPORT

Assessment of Soil Erosion Along Intensively Used Hiking Trails in Djerdap National Park (Serbia)

Study Area: Djerdap National Park, Serbia

Date: Spring 2026

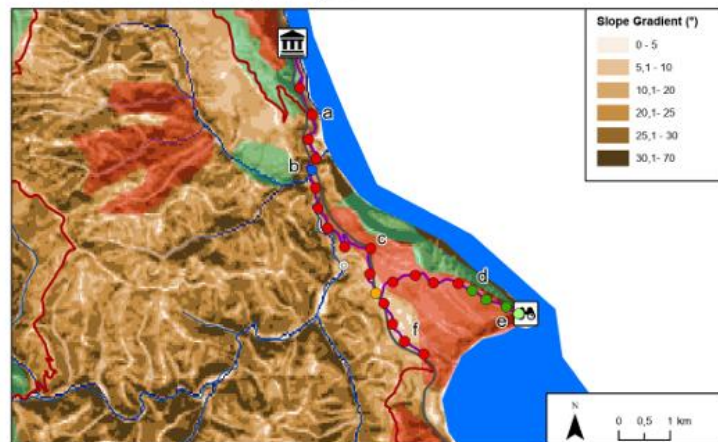
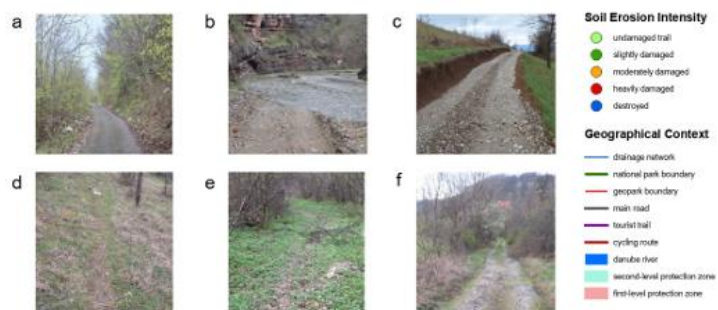
Figure 3: Detailed Assessment of Soil Erosion along Intensively Used Hiking Trails – Lepenski Vir Section, Djerdap National Park (Serbia), Spring 2026

The highest concentration of heavily eroded segments is located near the Lepenski Vir archaeological site and along the main road. These trails primarily consist of gravelled tourist paths and cycling routes, which are subject to intensive use and surface disturbance. Consequently, these areas are represented predominantly by red points indicating severe erosion.

A notable exception is represented by a blue point classified as a destroyed trail. This location corresponds to a valley where surface runoff converges, as confirmed by the flow accumulation analysis. Due to heavy rainfall during the survey period, the trail was washed away and became impassable. This section poses

a safety risk for visitors, who are required to cross fast-flowing water, and was therefore categorized as a special case of extreme erosion.

In contrast, the least affected segments are concentrated near the Greben viewpoint. These trails are situated along a low ridge and are located outside the built-up area. Represented by green points on the map, they exhibit minimal or no signs of erosion, reflecting stable terrain conditions and limited hydrological impact.

Overall, the Lepenski Vir section demonstrates varying degrees of erosion intensity, controlled by terrain morphology, hydrological processes, and visitor pressure. These findings highlight the importance of localized management measures to ensure both environmental protection and visitor safety.
